IMPORTANT PRODUCT SAFETY NOTICE

This is an important Product Safety Notice to all owners, distributors and service providers of the ProTeam GoFit 3 (model 1076620), GoFit 6 (model 1076630), GoFit 6 PLUS (model 1076650), and GoFit 10 (model 1076640) commercial backpack vacuum cleaners.

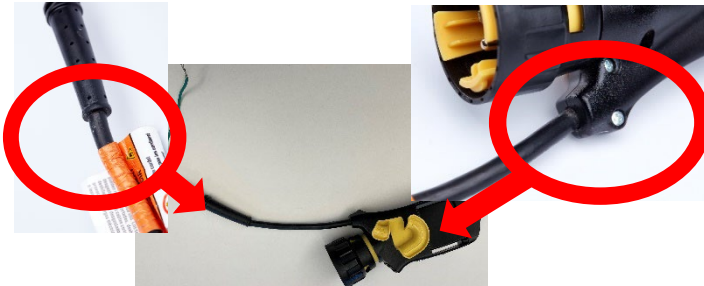
Figure 2
Locations of wear, such as gray discoloration
or exposed internal conductors

Issue: ProTeam recently received reports that some users of GoFit 3, GoFit 6, GoFit 6 PLUS, and GoFit 10 commercial backpack vacuum are not properly fastening the waist belt of the body harness and/or not wearing both shoulder straps of the harness, as required, which can cause stress on the switch box power cord and, after several months of use, can cause damage to the internal conductors (Figure 2), potentially resulting in the risk of overheating the switch box power cord and possible injury.

3. **Take Action** - If you identify wear or damage to the switch box power cord (Figure 2), immediately stop using the unit and have the damaged switch box power cord replaced before using. You can find local authorized service centers on our website, proteam.emerson.com/service-centers . If you cannot find a local center, have questions or need more help, please contact ProTeam Customer Service at customerservice.proteam@emerson.com or at 866-888-2168 for guidance and service options to assist in addressing the issue.
